1970-1972 INSTRUMENT PANEL REPAIR OF RADIO KNOB CUPS

Andy Filkins (i.e. Doctor Dash) has solved the problem of busted radio "stand-offs" by reproducing exact duplicates to the originals, but stronger. These replacement radio control cups are sturdier, injected in a black plastic composition and are easy to install with a minimum investment.

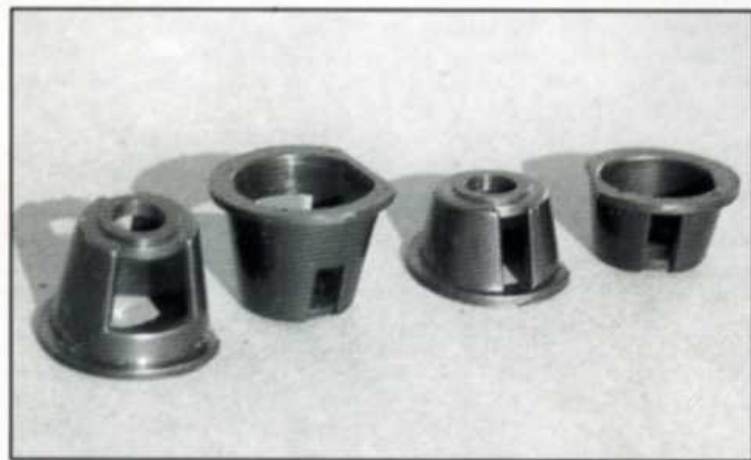
Stand-offs come as a pair for volume and station controls. They're identical to original design with correct cutouts and contours. Short cup is for volume control and tall cup is for station selector.

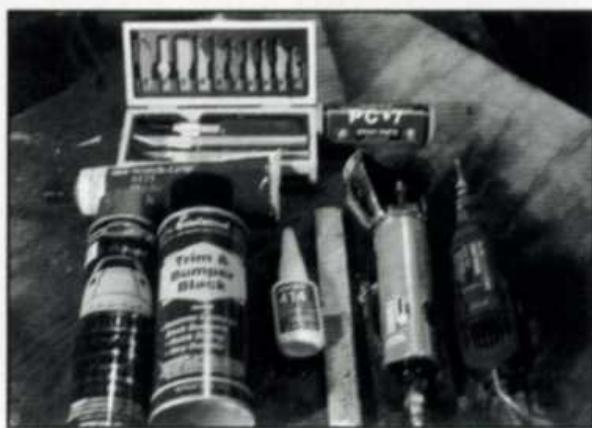
Materials to salvage dashboards are readily available from hardware store and specialty hobby businesses. Small grinder with shield, Dremel tool for close cavity work, Scotch Grip 4475 Plastic Adhesive, PC-7 Epoxy Paste, file, razor knives and paints.

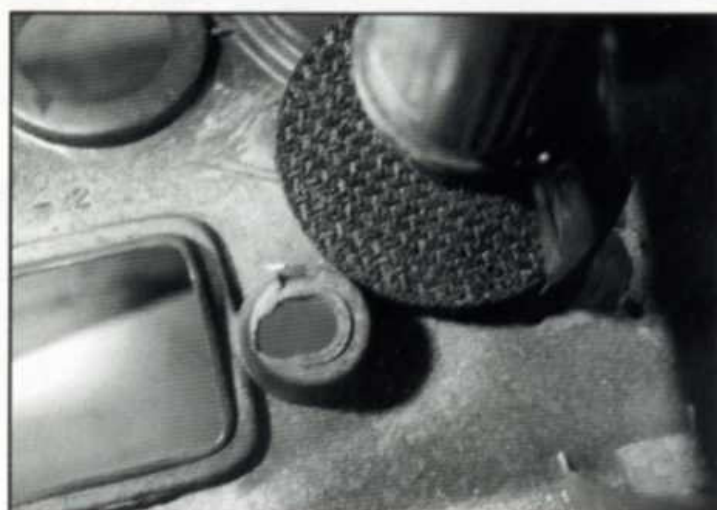
Volume control stand-off has similar damage. It's carefully eliminated with small grinder.

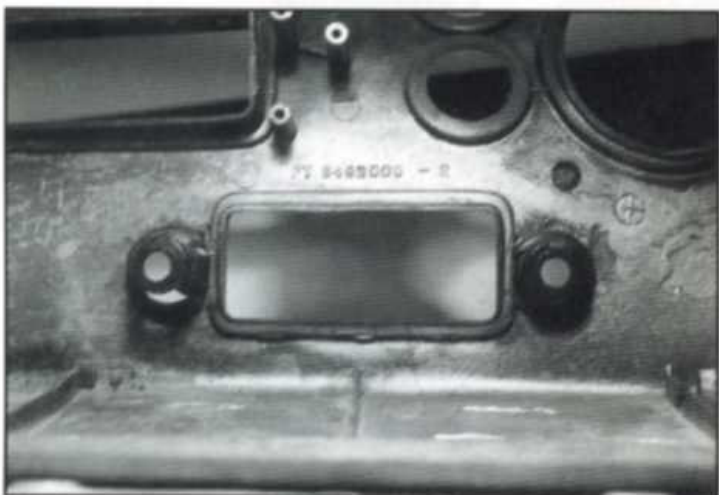
Both replacement cups are glued into place with Scotch-Grip 4475 Plastic Adhesive. Check alignment from front before glue sets. Allow adhesive to cure 24 hours.

Extra plastic was added to the flat side for damaged radio housing lips, so test fit the radio stand-offs and file only the flat side of the replacement to get correct fit. However, filing these new pieces is rarely necessary. Glue the stand-off in place and check alignment from the front of the dashboard. Scotch Grip #4475 Plastic Adhesive is recommended for ideal repair (Super Glue adhesives will not work). Let the glue cure for 24 hours.

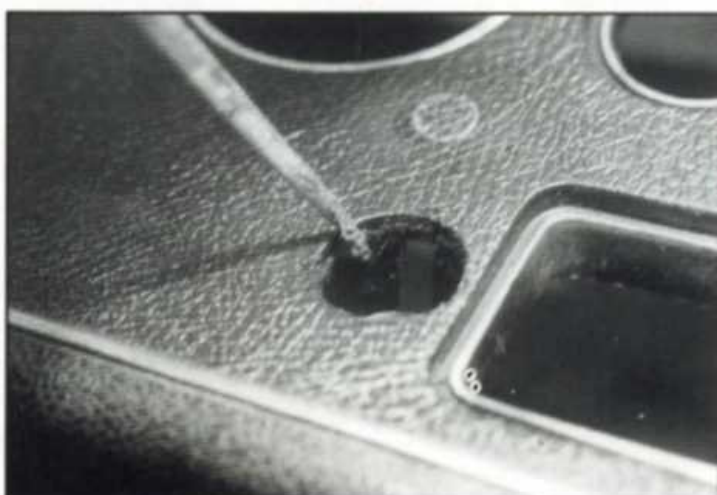
Mix PC-7 Epoxy Paste and conservatively fill connecting seam from front side of dashboard. After curing 24 hours, the excess can be sanded to factory-like appearance.

When glued to the dash, the inside of the cups will have a seam that can be filled with PC-7 Epoxy Paste. This product adds strength to the new stand-offs and should be added to the base of the stand-offs to strengthen the repair. And, while on the back side of the dashboard, it's recommended that the epoxy covers the base of the cups. Finally, sand the inside of the cups and paint to match.

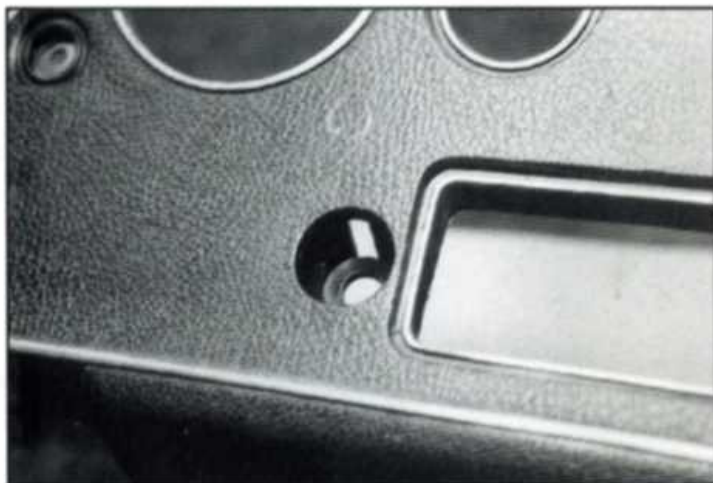
Volume control stand-off replacement after seam has been strengthened, sanded and entire dash area has been repainted.

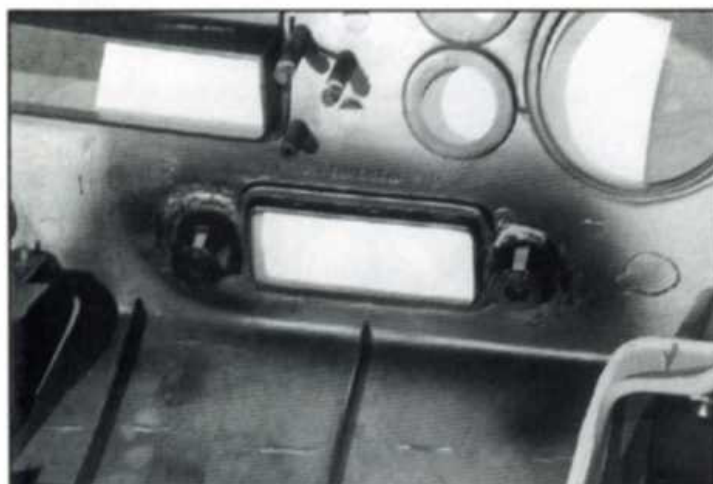
PC-7 Epoxy Paste is added to base of each cup to strengthen adherence of stand-off to dashboard. Cover lip of base and slope to dashboard. Finished product on back side can be painted, too.

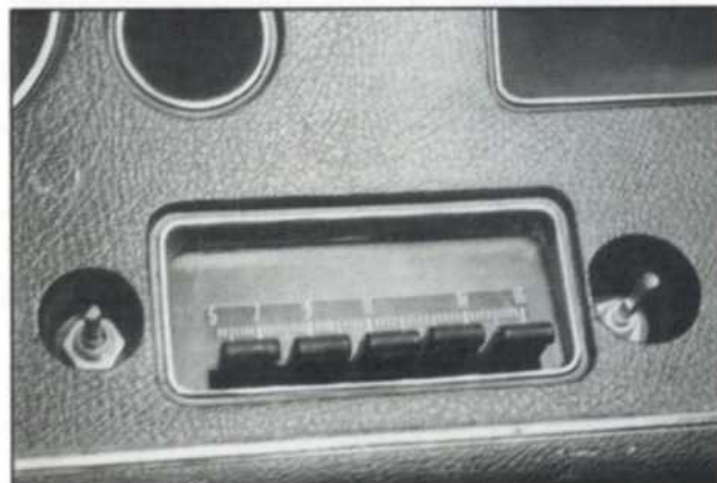
Another dash has been salvaged and made new with Doctor Dash's radio cup stand-offs. With proper installation, there's no evidence that these delicate areas of dash have been repaired.
